# Investigation Report for Environmental Complaint

Ref. No.: ORRC-EC-001-20180907

OSCAR Bioenergy Joint Venture  
EP/SP/61/10 - Organic Waste Treatment Facilities Phase 1

Organic Resources Recovery Centre (Phase 1)

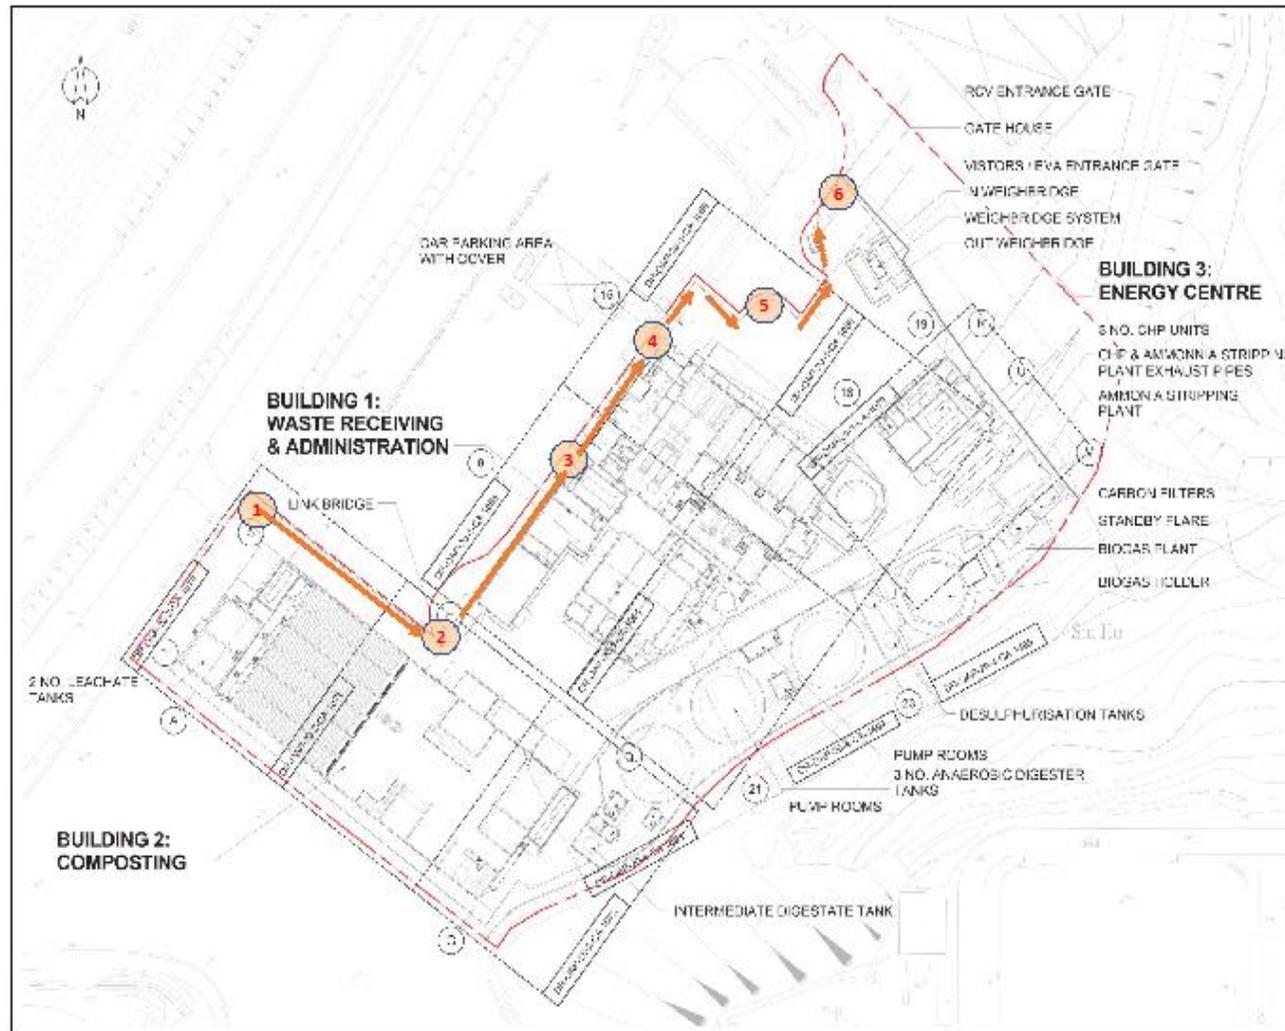
## Ad hoc Odour Patrol Route

Location	Panellist	Weather	Time	T (°C)	RH (%)	WS (m/s)	WD (Deg)	Odour Intensity	Duration of Odour	Direction from Source	On-Site Observation	
											Odour Characteristics	Potential Odour Source
1	1	Cloudy	16:15	28.7	77.9	0.8	309	1	Intermittent	Downwind	Grassy	Trees and grass
	2							1				
2	1	Cloudy	16:19	29.2	77.4	0.9	324	0	NA	NA	NA	NA
	2							0				
3	1	Cloudy	16:22	28.9	77.4	0.0	NA	0	NA	NA	Grassy	Trees and grass
	2							1	Intermittent			
4	1	Cloudy	16:25	28.9	75.4	1.1	253	1	Intermittent	Downwind	Smell of concrete and garbage	Construction waste container
	2							1				
5	1	Cloudy	16:30	28.9	81.6	0.0	NA	1	Intermittent	NA	Musty smell of construction material	Construction material storage zone
	2							1				
6	1	Cloudy	16:36	29.1	76.8	0.0	NA	0	NA	NA	NA	NA
	2							0

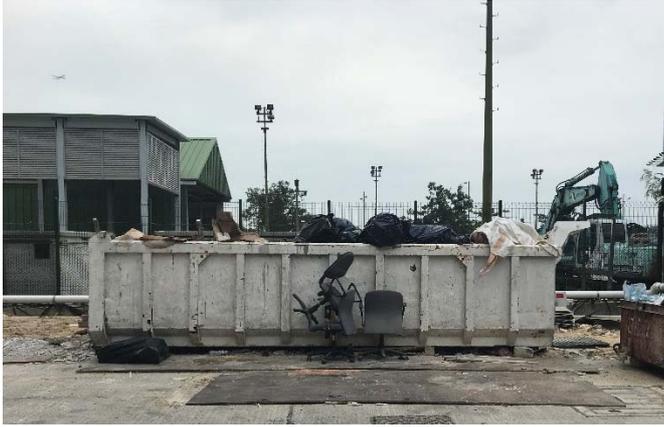
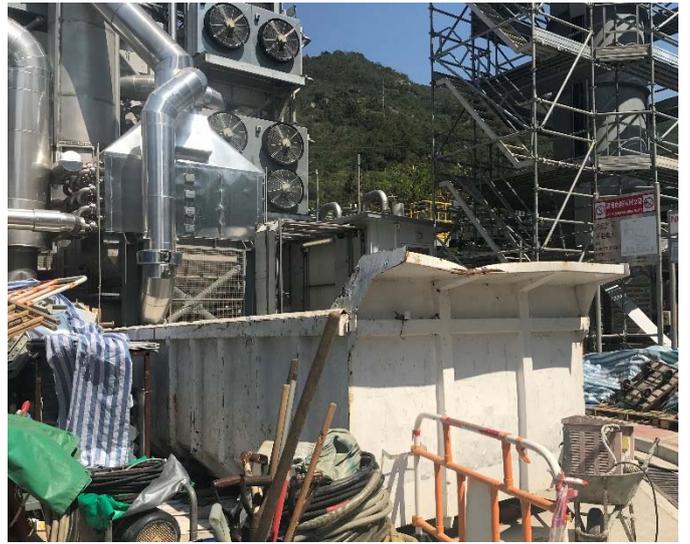
Before

After

Construction waste skip was relocated.

<p>potential source of the odour nuisance and flies) was moved away from the site boundary next to the Compound on 11 September 2018, and the storage area next to the original location of the construction waste skip had been properly cleaned. The photographic records are shown in <b>Appendix B</b>.</p> <p>3. An investigation of the potential mosquito generation locations was conducted on 11 September 2018 by OSCAR, ER (AECOM) and ET (ERM). The photographs of the surveyed potential mosquito generation locations are shown in <b>Appendix C</b>.</p> <p>4. The frequency pest control at the Facility will be increased from twice a week to three times a week.</p>
Remarks	-

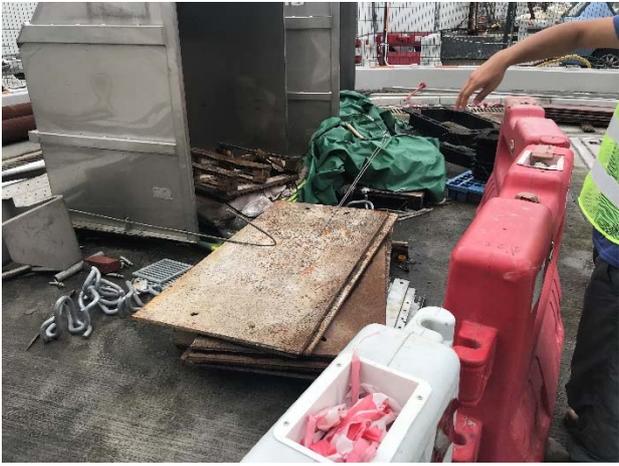
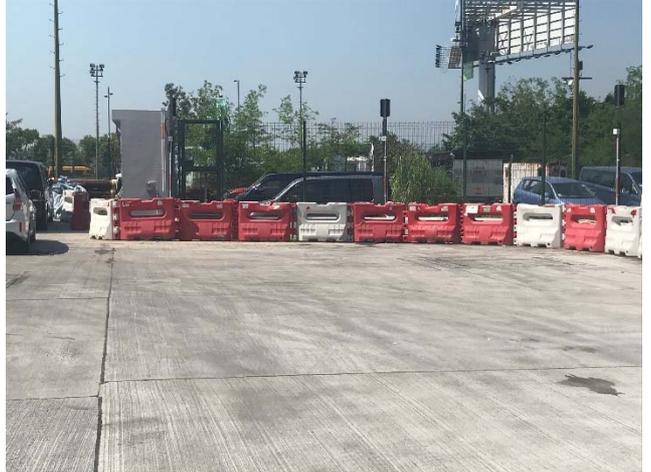
Storage area was properly cleaned up.
