Investigation Report for Environmental Complaint

Ref. No.: ORRC-EC-001-20180907

Organic Resources Recovery Centre (Phase 1)

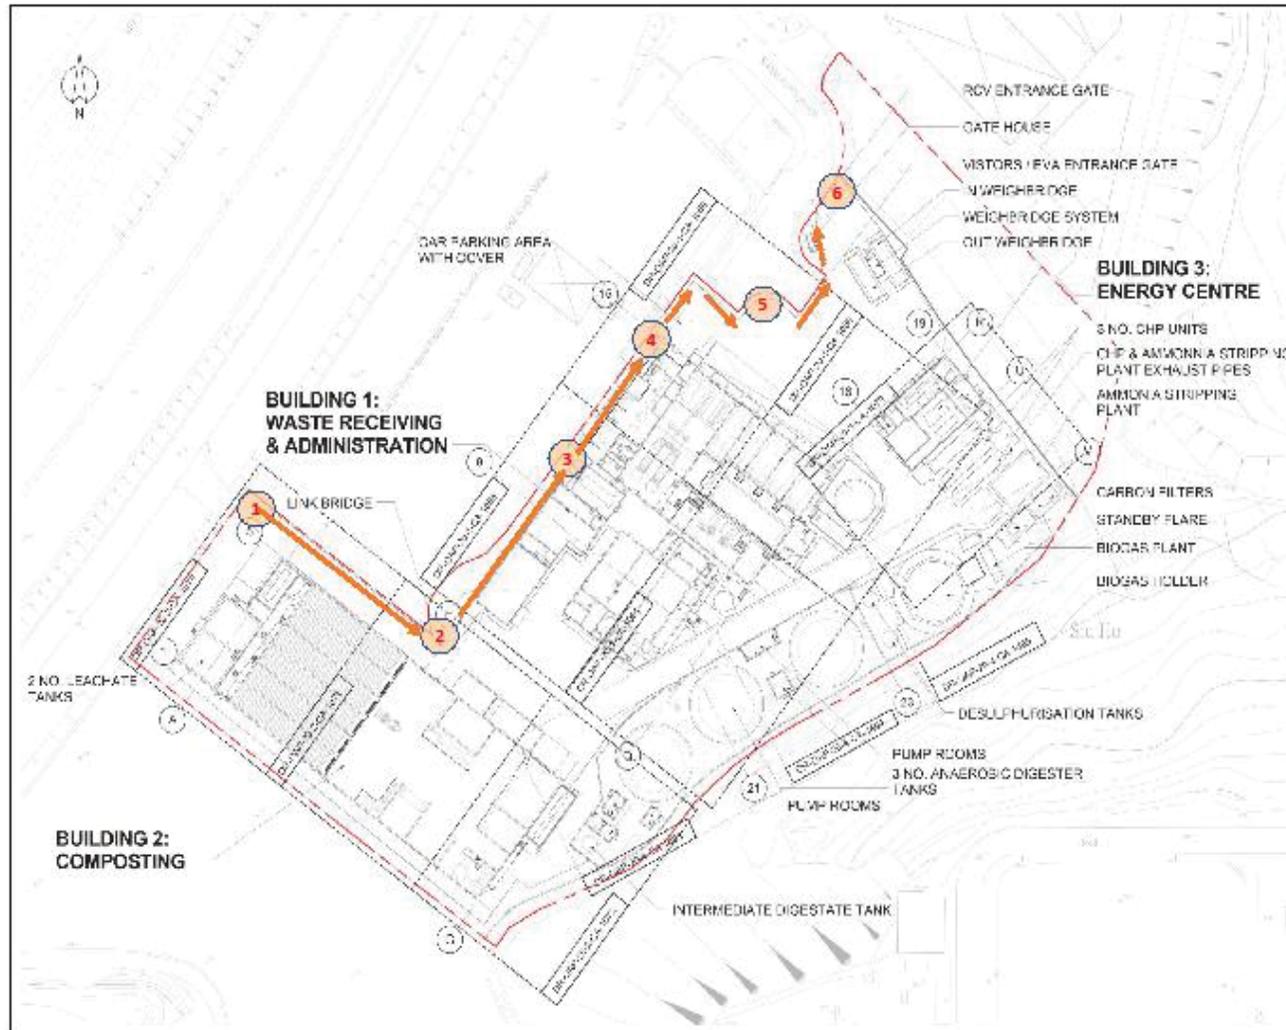
Ad hoc Odour Patrol Route

→ Proposed Patrol Route

10 Possible Odour Sources (No.) / Checkpoint

1 Estimated Odour Intensity
From 1 (min.) to 3 (max.)

The ad hoc odour patrol locations were shown in Appendix 1.

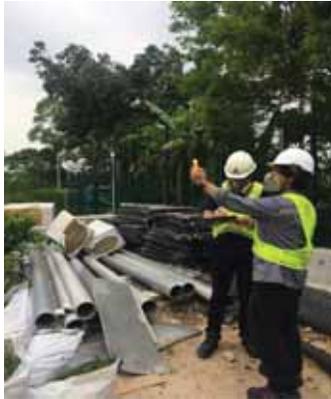
Location: 1

Location	Panellist	Weather	Time	T (°C)	RH (%)	WS (m/s)	WD (Deg)	Odour Intensity	Duration of Odour	Direction from Source	On-Site Observation	
											Odour Characteristics	Potential Odour Source
1	1	Cloudy	16:15	28.7	77.9	0.8	309	1	Intermittent	Downwind	Grassy	Trees and grass
	2							1				
2	1	Cloudy	16:19	29.2	77.4	0.9	324	0	NA	NA	NA	NA
	2							0				
3	1	Cloudy	16:22	28.9	77.4	0.0	NA	0	NA	NA	Grassy	Trees and grass
	2							1	Intermittent			
4	1	Cloudy	16:25	28.9	75.4	1.1	253	1	Intermittent	Downwind	Smell of concrete and garbage	Construction waste container
	2							1				
5	1	Cloudy	16:30	28.9	81.6	0.0	NA	1	Intermittent	NA	Musty smell of construction material	Construction material storage zone
	2							1				
6	1	Cloudy	16:36	29.1	76.8	0.0	NA	0	NA	NA	NA	NA
	2							0

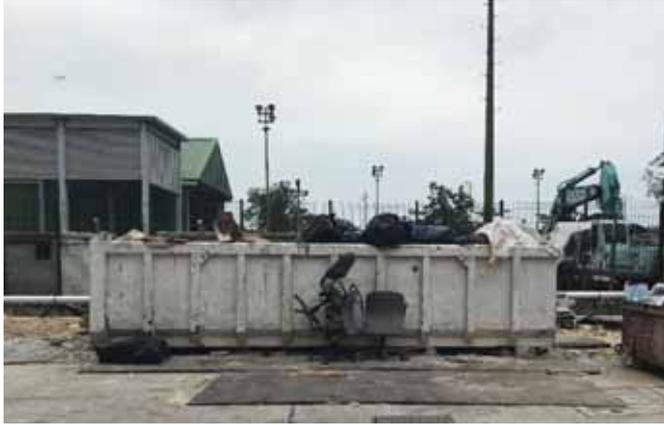
Before

<p>potential source of the odour nuisance and flies) was moved away from the site boundary next to the Compound on 11 September 2018, and the storage area next to the original location of the construction waste skip had been properly cleaned. The photographic records are shown in Appendix B.</p> <p>3. An investigation of the potential mosquito generation locations was conducted on 11 September 2018 by OSCAR, ER (AECOM) and ET (ERM). The photographs of the surveyed potential mosquito generation locations are shown in Appendix C.</p> <p>4. The frequency pest control at the Facility will be increased from twice a week to three times a week.</p>
Remarks	-

Construction waste skip was relocated.

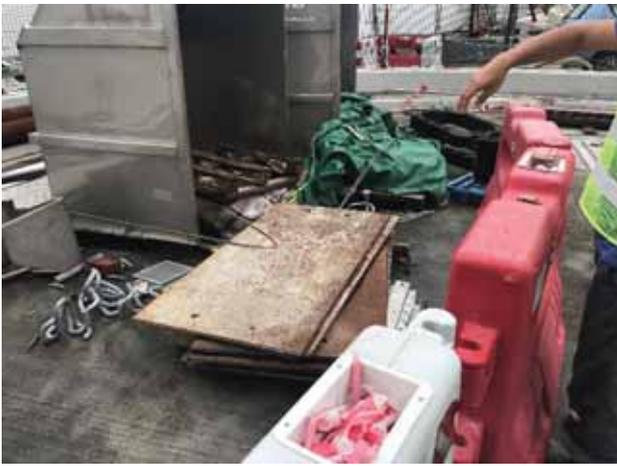
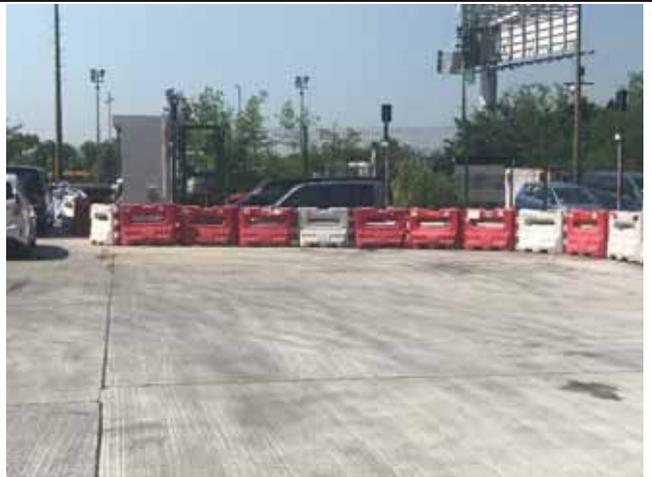
Storage area was properly cleaned up.

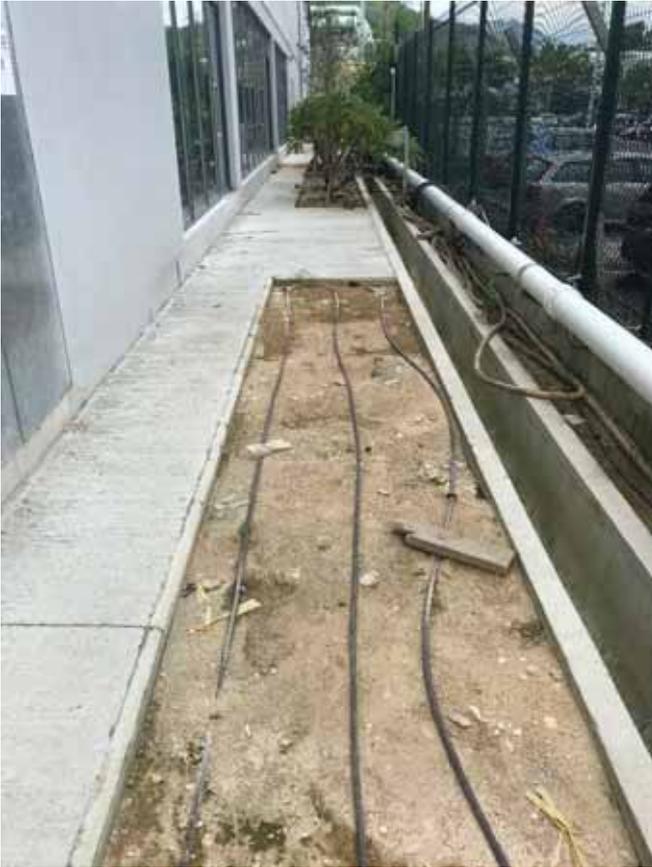
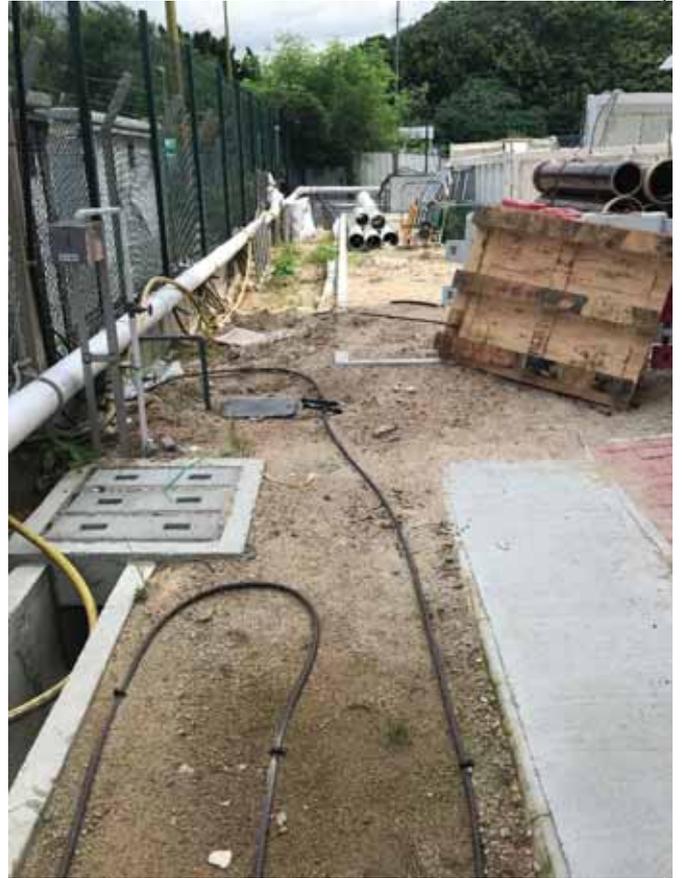
Near Building 1

Mosquito Control Points
